PROPERTY CONDITION ASSESSMENT

1234 Main Street, Los Angeles, CA, 90024

Report Name: Main Street Office Building

Building: Main Street Office Complex

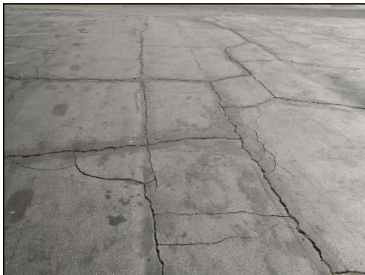
Figure 1: parking lot_2

1.1.13 There are significant cracks or offsets in the driveway, which could prove to be trip-hazards and should be serviced.

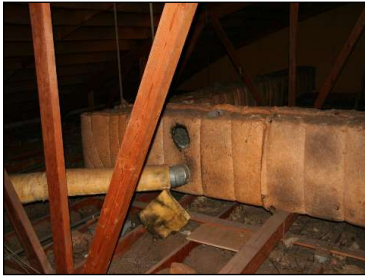
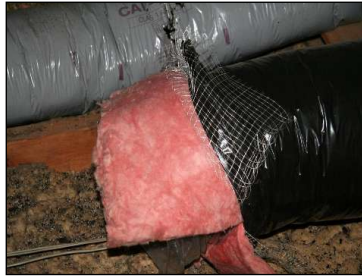
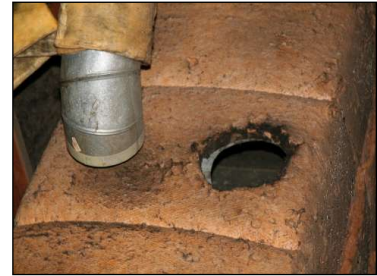
- 1.1.52 The systems have not been well maintained: the filters are completely clogged, and poor maintenance has contaminated the coils, which will need to be cleaned; the original ducts were a light-gray, u-v susceptible type, and although many of them have been replaced with a u-v resistant type, portions of the ducts are uninsulated and there are several openings in the ducts and plenums, where energy is being lost into the attic area. Neither system responded well on the cooling cycle, and both will need to be charged when they have been cleaned. However, you should ascertain the cost of the repairs, so that you can decide whether you wish to invest the amount in old systems or apply it to the cost of new ones. Regardless, we will indicated the cost of replacing the systems.

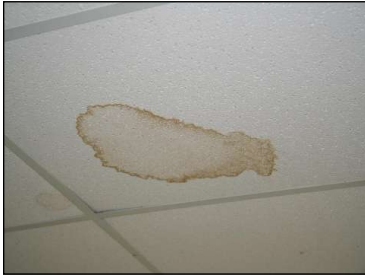
Figure 1: exam room 0_05

1.2.3 There is a moisture stain on the ceiling, which you should ask the sellers to explain or have explored further.

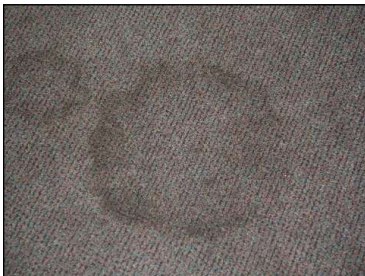
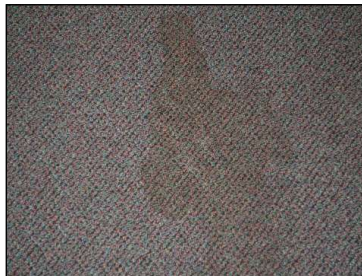
1.2.7 The finished floor has wear or damage and stains that are commensurate with its age.

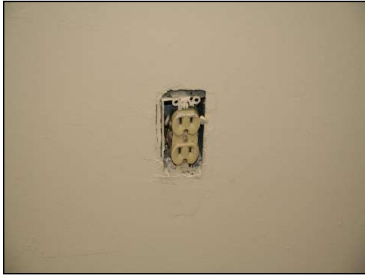
Figure 1: exam room 3_01

1.2.10 We have tested the unobstructed outlets and found them to be functional. However, one coverplate is missing.

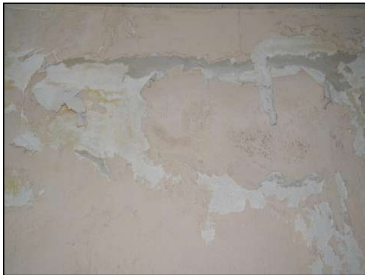
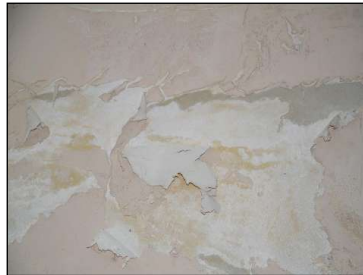
1.2.13 There is evidence of moisture intrusion with efflorescence that we will identify, but you should ask the sellers about this or have the condition evaluated by a grading and drainage contractor. The cost of renovating the walls will obviously vary depending upon the

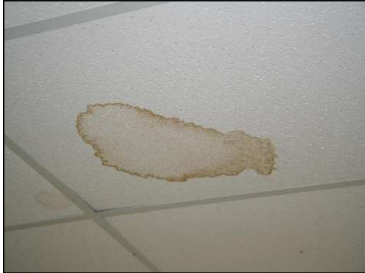
Figure 1: exam room 0_05

1.5.1 There is a moisture stain on the ceiling, which you should ask the sellers to explain or have explored further.
